**Surface Radiological Investigations
at
White Wing Scrap Yard**

ORNL/ER/INT-1

Date Published—June 1990

Prepared by
Health and Safety Research Division

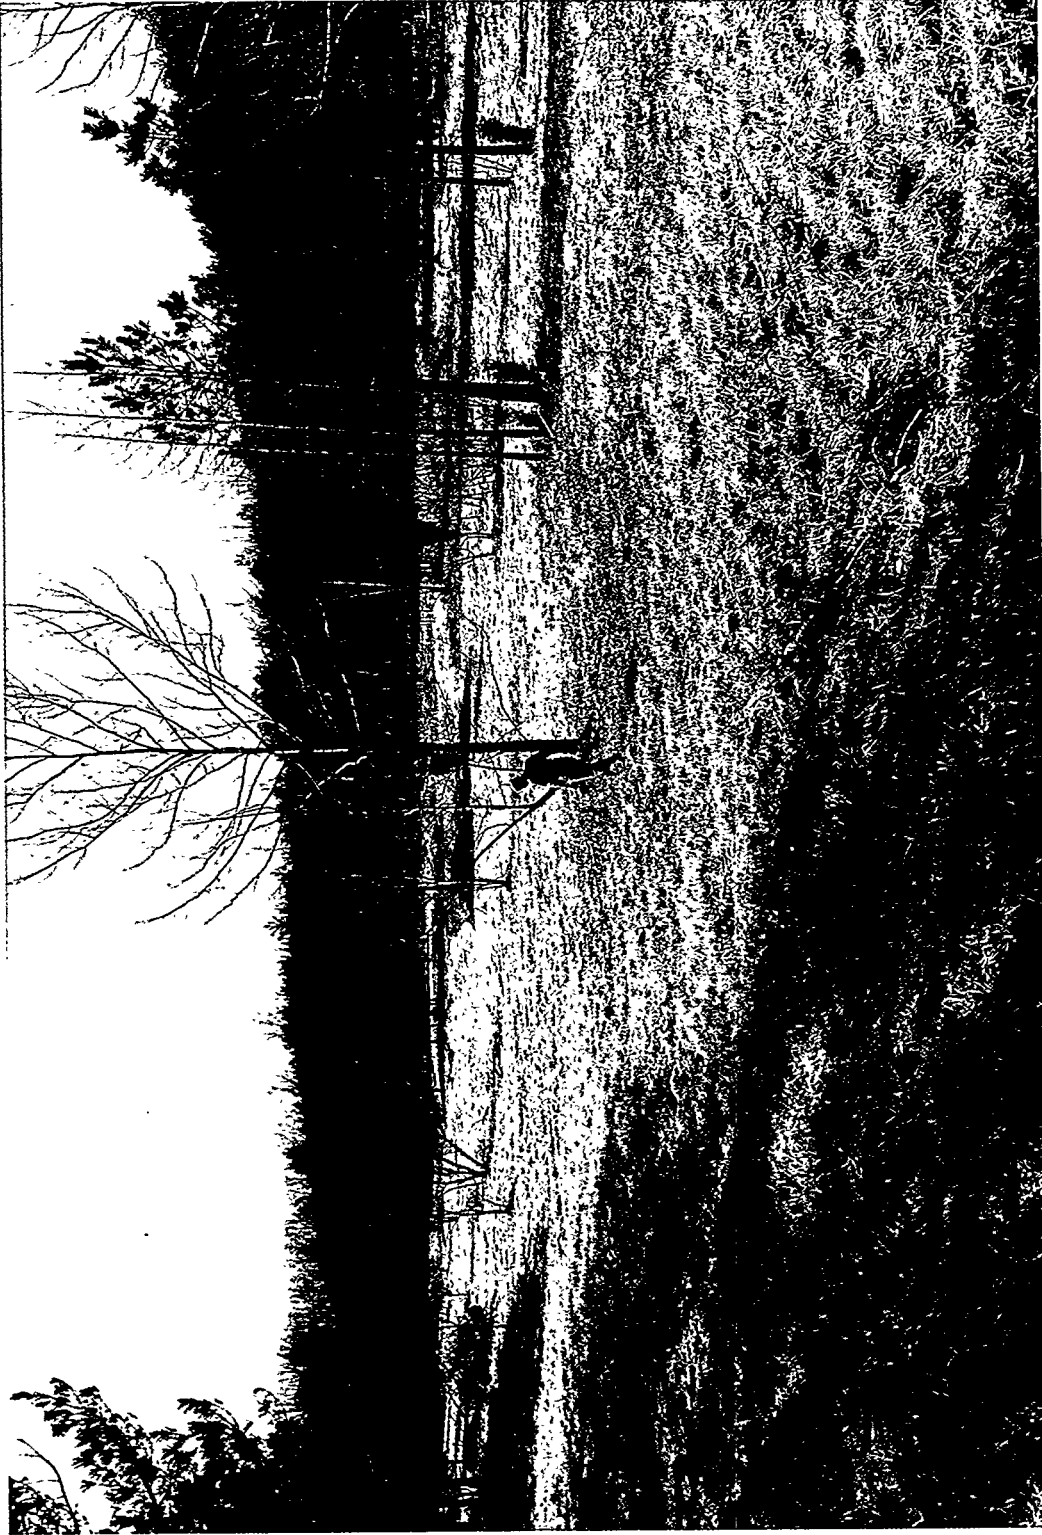
ORNL-PHOTO 402-90

Fig. 2.7. View looking west at large field where past aboveground storage of contaminated scrap occurred at the White Wing Scrap Yard site (January 1990). Reportedly this area was used by ORGDP.

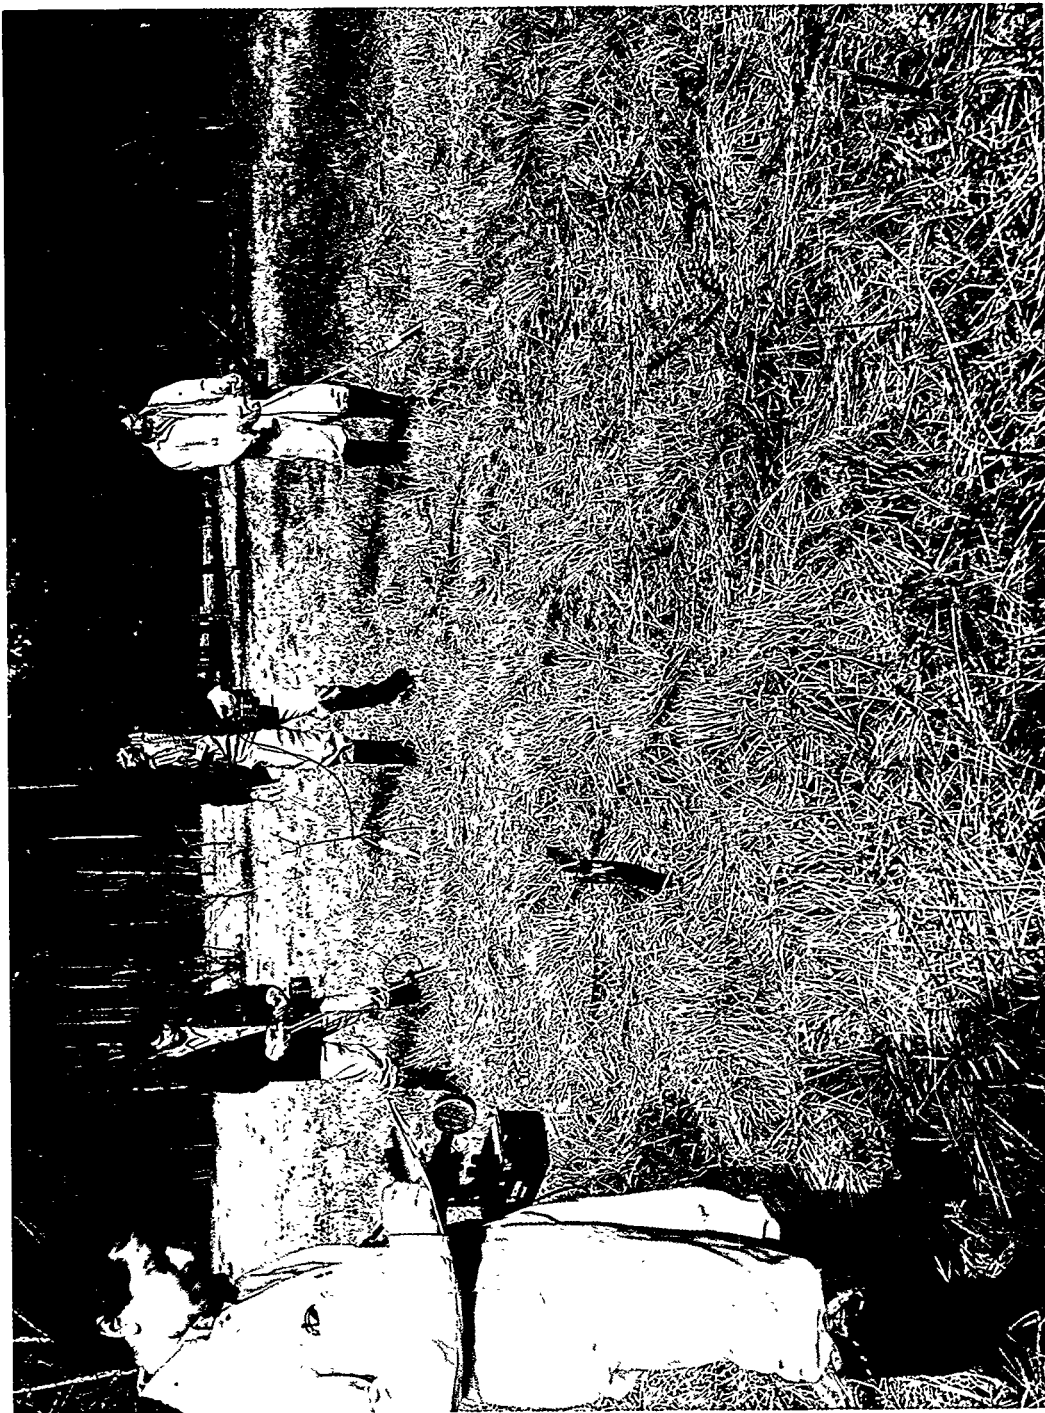
ORNL-PHOTO 401-90

Fig. 3.2. Radiological survey team conducting a surface gamma scan at the White Wing Scrap Yard site (January 1990).

- Gamma exposure rate measurements at 1 m above the ground surface and at the surface at accessible grid points.
- A surface gamma scan (Fig. 3.2) of accessible land areas [$\sim 53,000$ m² (13 acres)], including Hot Yard Road. Surveyed grid blocks are shaded in Fig. 3.1. The NaI scintillation probe held approximately 5 cm (2 in.) above the ground surface was used to detect gamma radiation. The gamma scan of Hot Yard Road was conducted prior to the recent addition of gravel material (Fig. 3.3).
- Beta-gamma and alpha spot-check measurements of selected scrap material.
- Isotope dilution/mass spectrometry analysis and gamma spectrometry screening of selected samples.

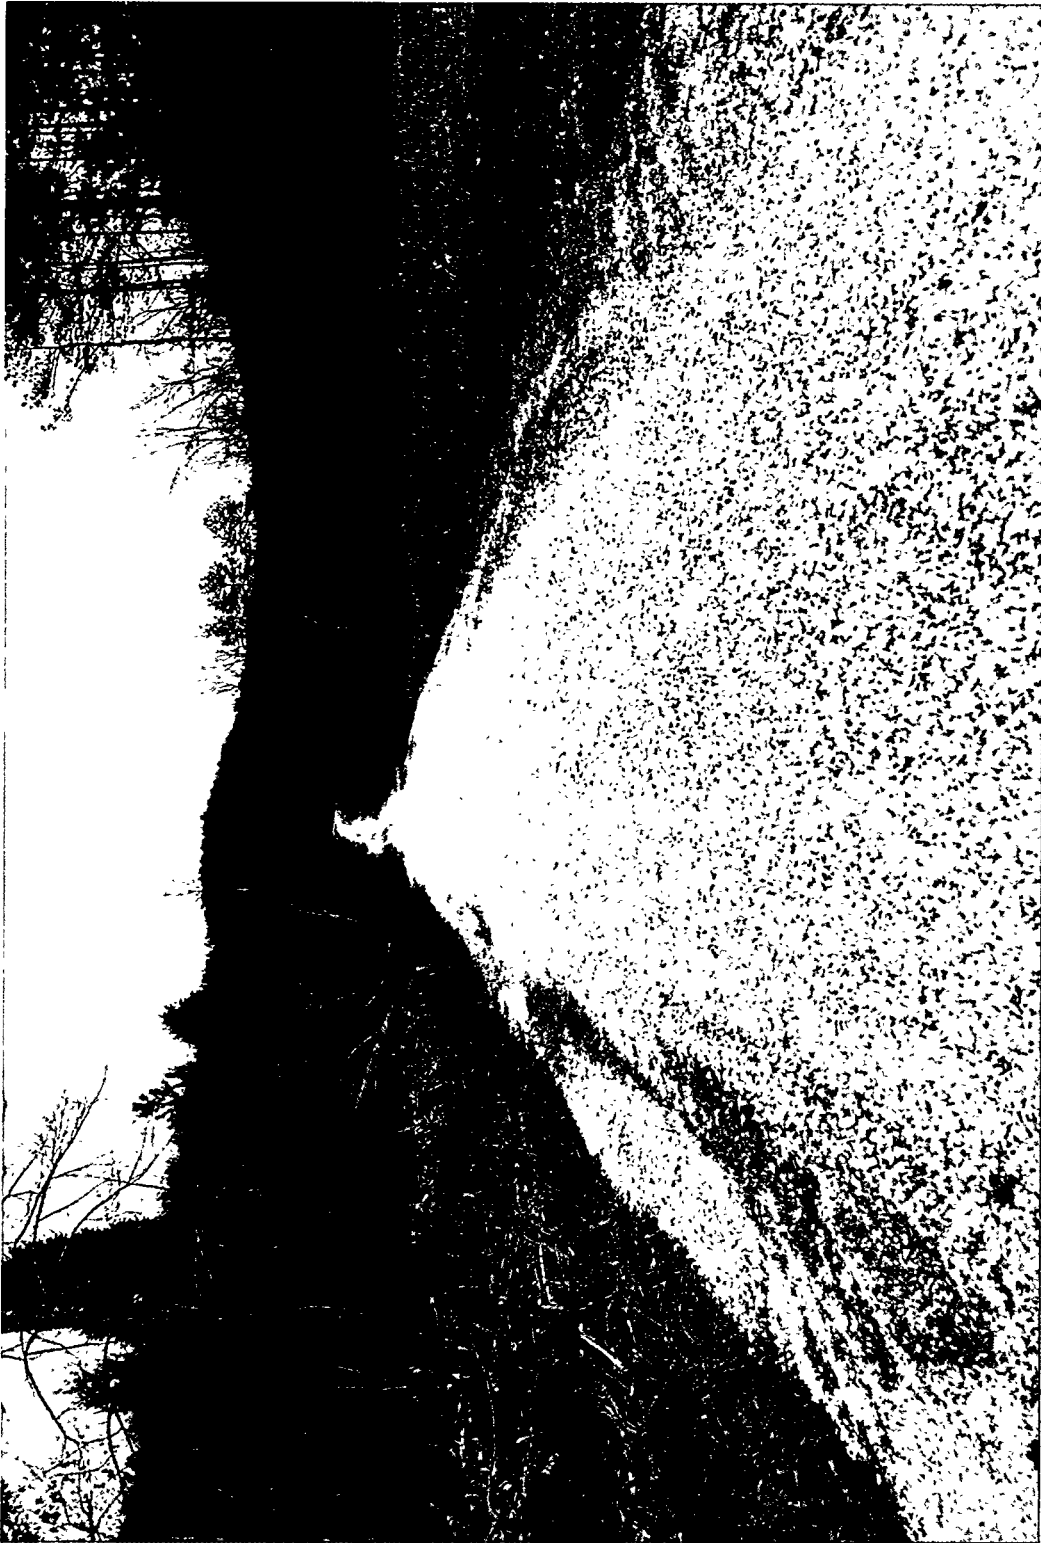
ORNL-PHOTO 385-90

Fig. 3.3. View looking east at Hot Yard Road at the White Wing Scrap Yard site (January 1990).

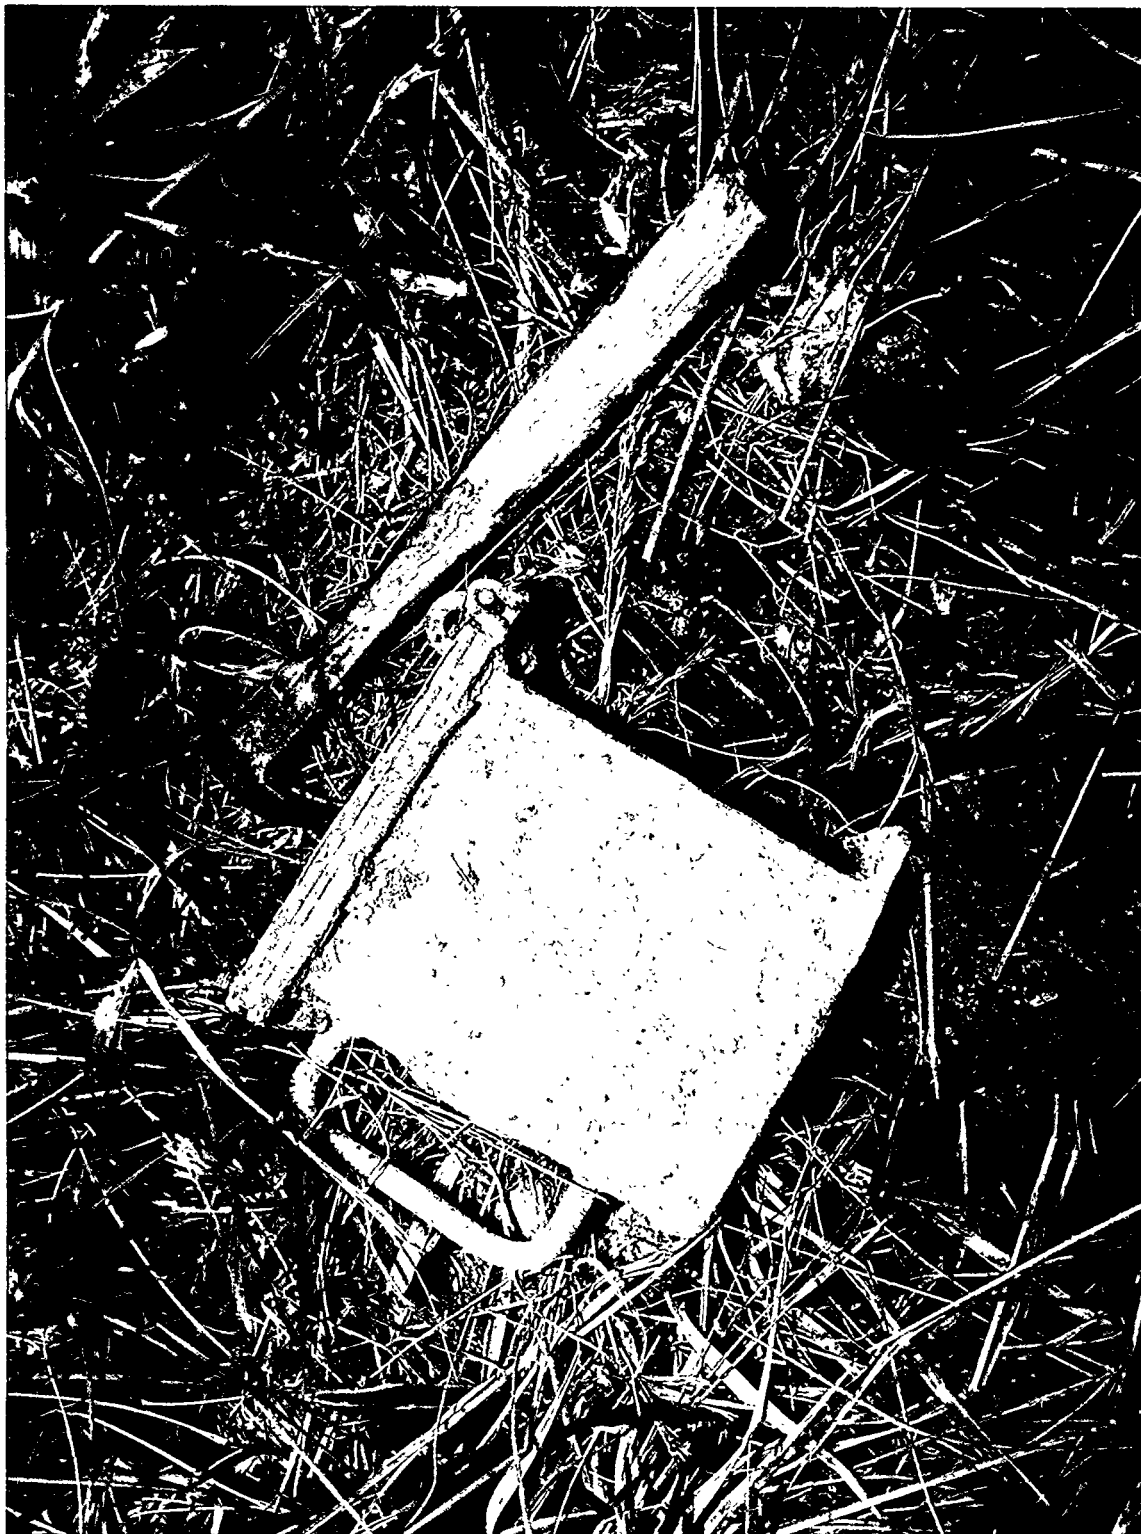
K/PHOTO 90-1801

A small, sealed gray metal box (Fig. 4.4) showing contact beta-gamma measurements of 9 mrad/h was found in grid block 1+00, 600L. "Determined to be Cadmium" was inscribed on the exterior of the box. After the box was carefully opened, interior measurements showed very low levels of radioactivity. Gamma spectrometry screening analysis of a smear sample collected from the exterior surface identified ^{238}U as the primary contaminant.

Fig. 4.4. Photograph of a contaminated metal box located in the ORGDP area of the White Wing Scrap Yard site (June 1990). A hammer is included for size comparison purposes only.

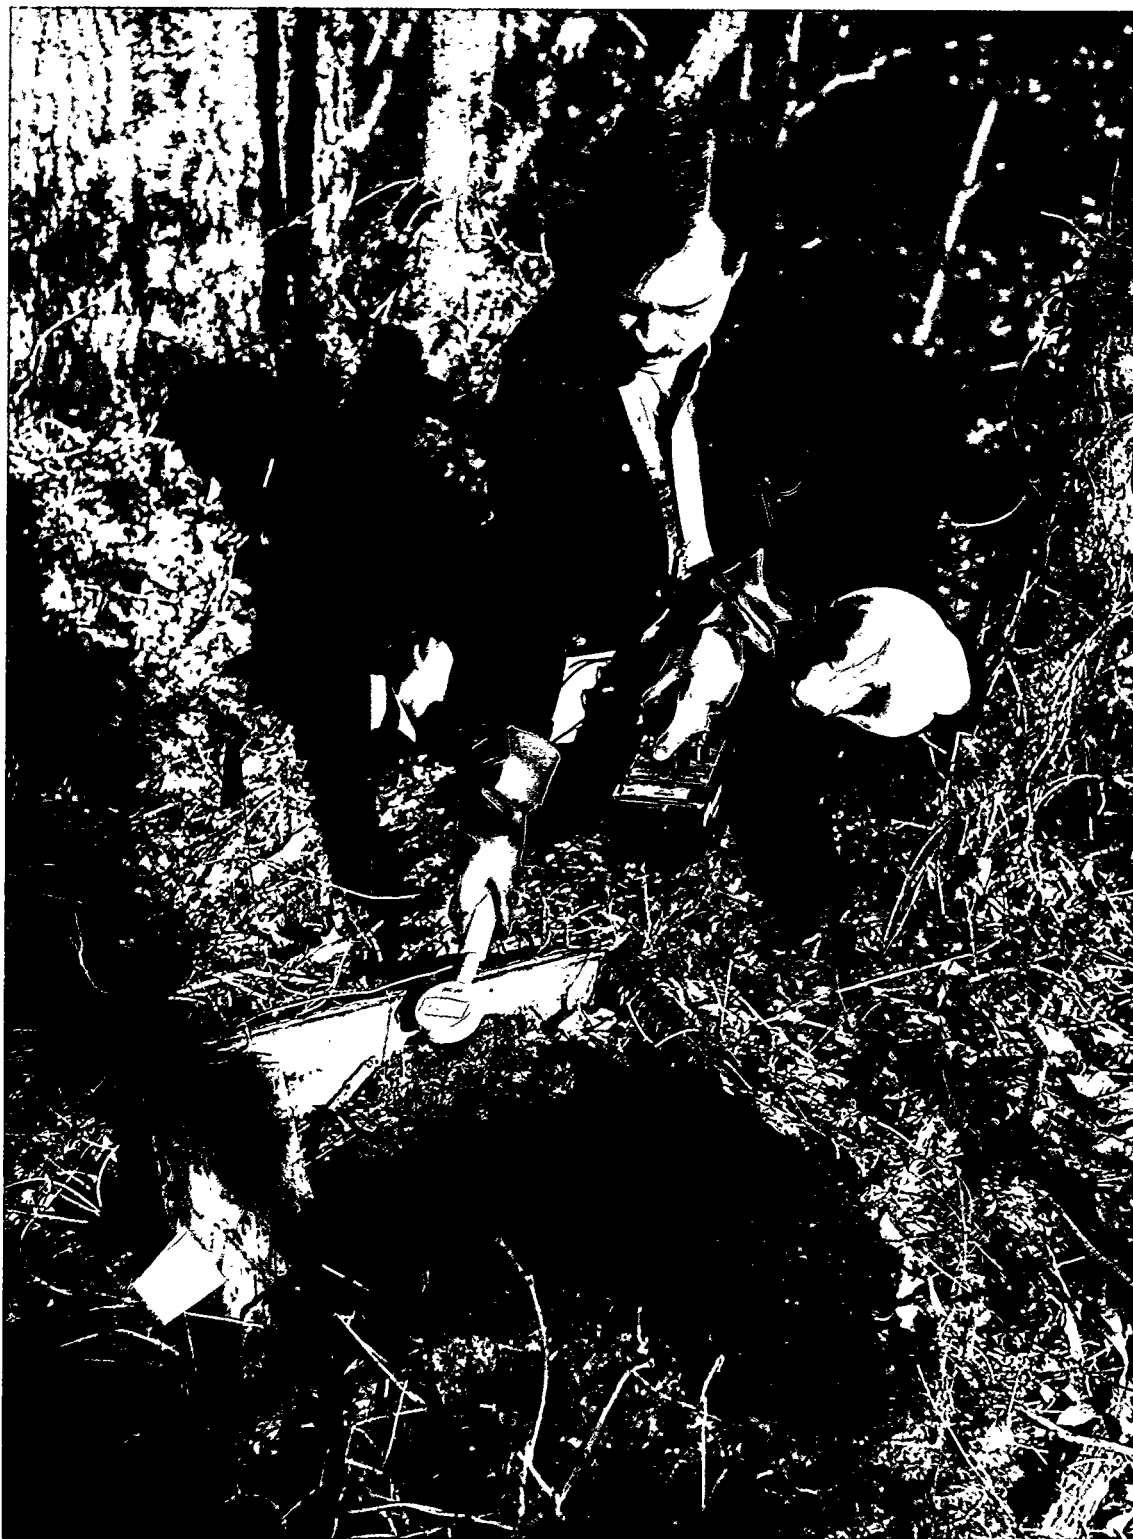
Isotope dilution/mass spectrometry analysis results of sample B2 (green material) and sample B3 (yellowish-gray material) showed total uranium concentrations comprising ~40% and ~80% by weight, respectively, of the analyzed sample. X-ray diffraction spectra indicated that sample B2 was a probable mixture of uranium fluoride and uranium oxide compounds. Sample B3 was identified as uranyl hydroxide [$\text{UO}_2(\text{OH})_2$]. Locations of sampling sites are depicted in Fig. 4.2. Field photographs of samples B2 and B3 are shown in Figs. 4.6 and 4.7, respectively.

Fig. 4.6. View of the green uranium-contaminated material found on the ground surface north of Hot Yard Road at the White Wing Scrap Yard site (January 1990).

1. Highly radioactive, green-colored aggregate lumps of material (Fig. 4.6), located north of Hot Yard Road (grid 7+79, 177L), were found deposited in what appeared to be an old wood-framed air filter lying on the ground surface. Gamma exposure rate measurements on contact with a plastic bag containing a sample of this material showed levels of up to 2.5 mR/h; beta-gamma dose rates measured 7 mrad/h. Isotope dilution/mass spectrometry analysis results show uranium concentrations of ~40% by weight (probable composition, a mixture of uranium fluoride and uranium oxide compounds; sample B2).
2. On the top side of a large, oblong concrete structure immediately north and adjacent to Hot Yard Road (grid location 6+44, 20L), a coarse, yellowish-gray material was found to be highly radioactive (see Fig. 4.7). Gamma exposure rate measurements on

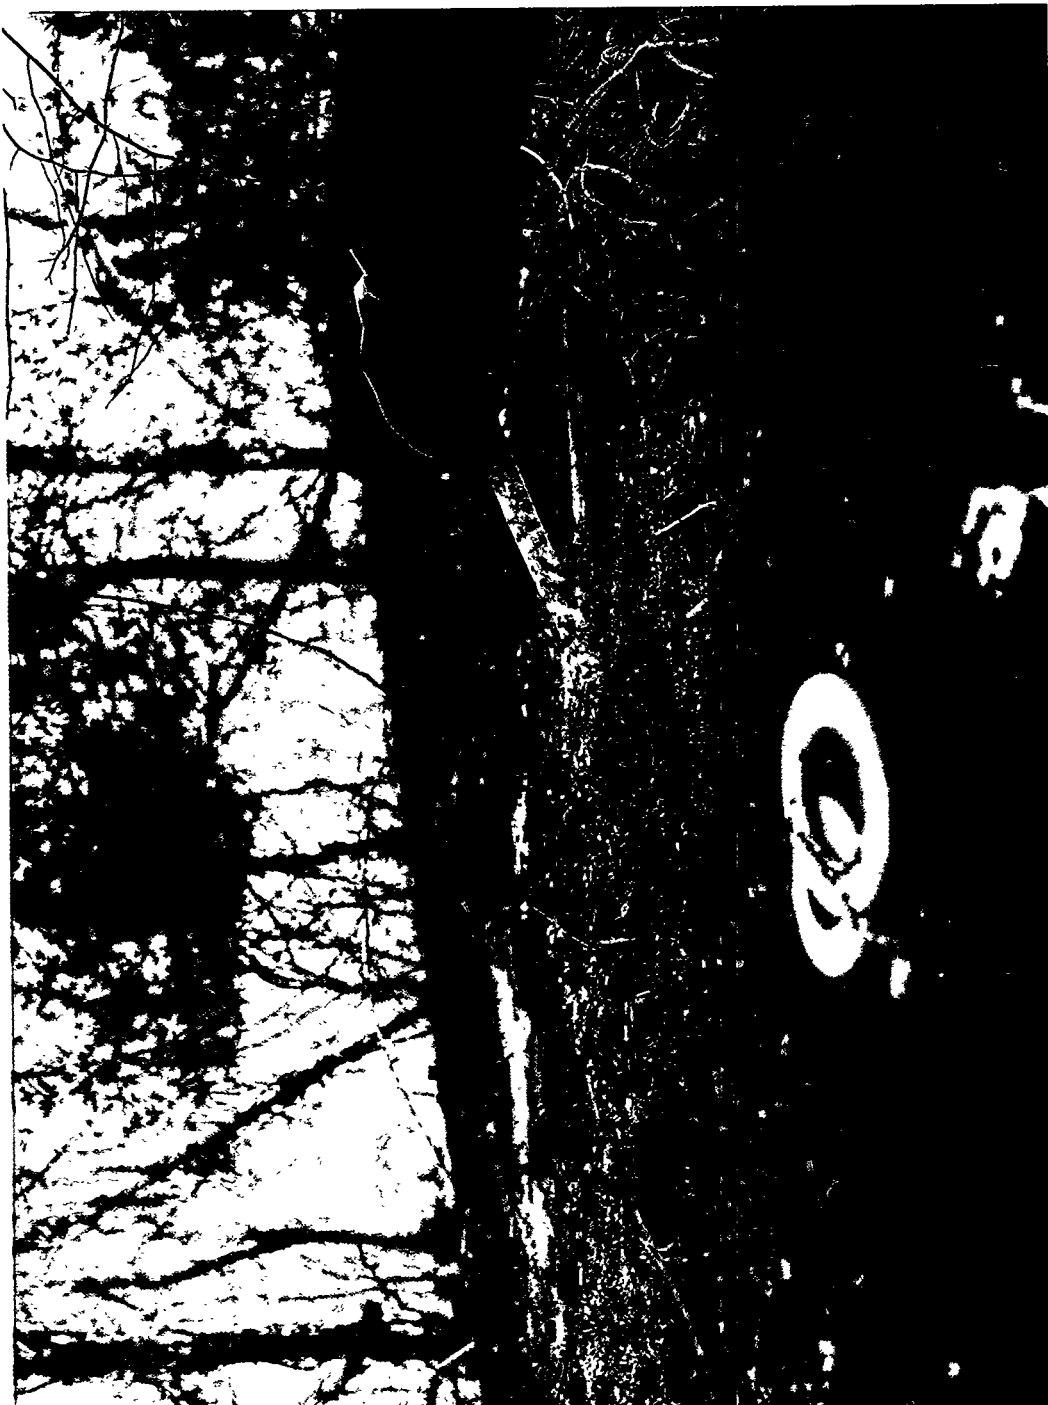
ORNL-PHOTO 1565-90

Fig. 4.7. View of the yellow uranium compound found on the top side of a large, concrete structure at the White Wing Scrap Yard site (January 1990).

contact with a plastic bag containing a sample of this material showed levels of up to 5 mR/h; beta-gamma dose rates measured 15 mrad/h. Isotope dilution/mass spectrometry analysis results show uranium concentrations of ~80% by weight (composition, uranyl hydroxide; sample B3).

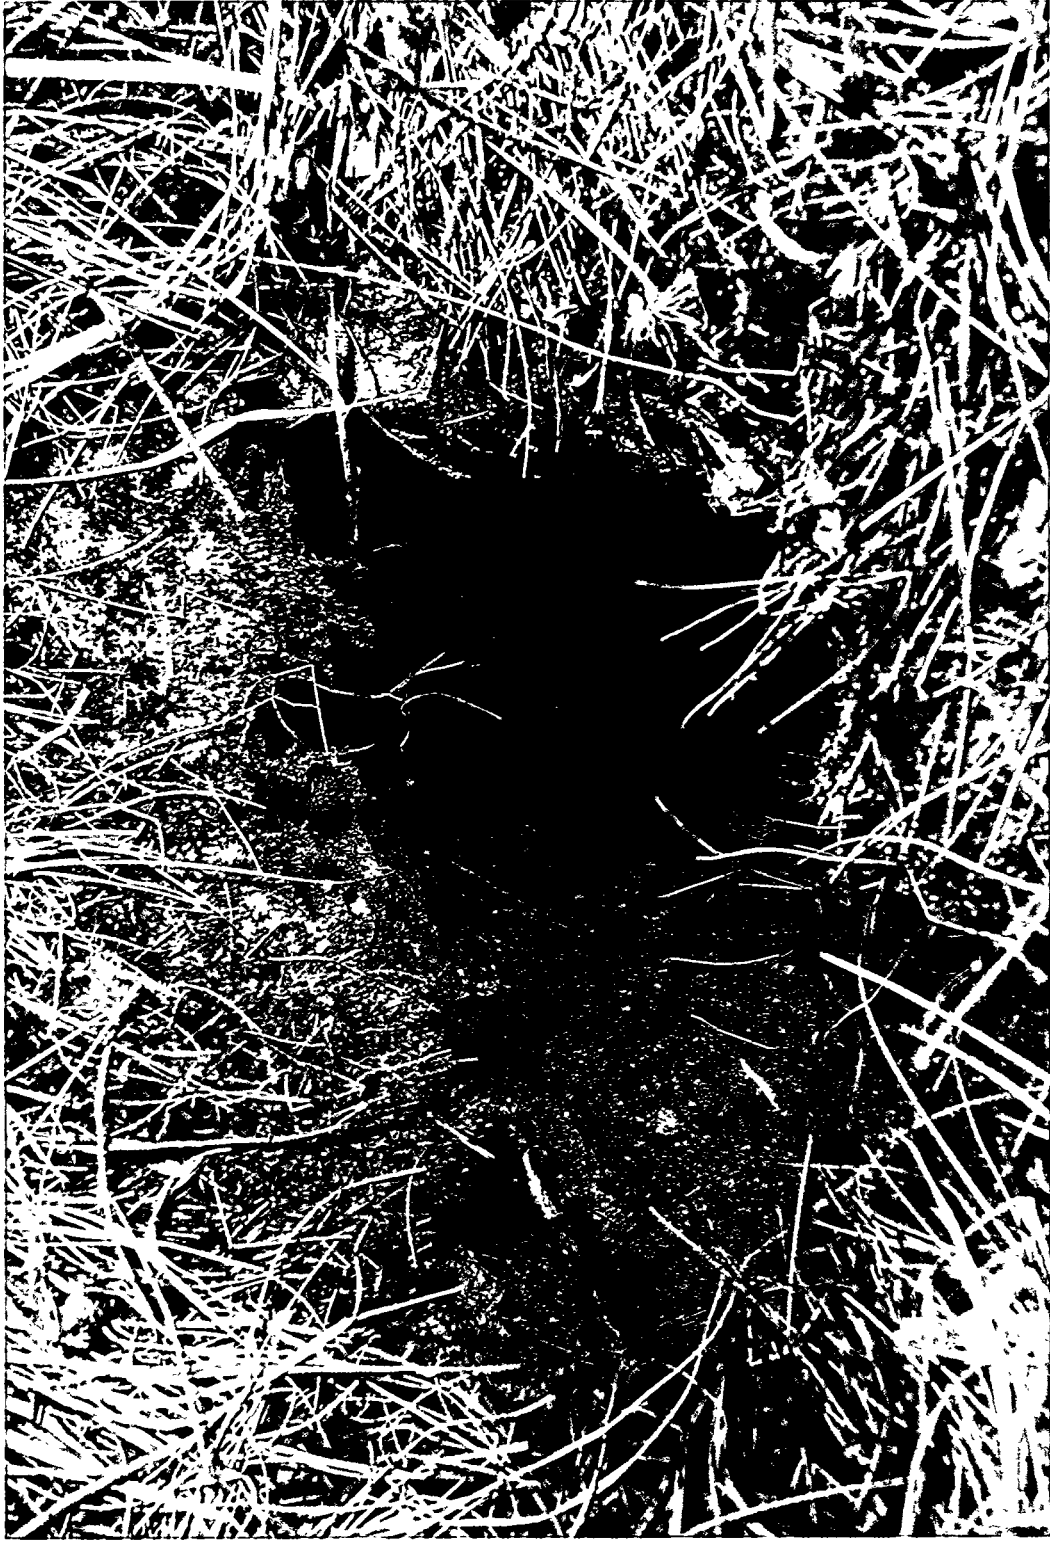
ORNL-PHOTO 404-90

3. In a wooded area north of Hot Yard Road (grid location 6+14, 100L), a small (~1-m²) area of surface subsidence [~1.5 m (5 ft) in depth] revealed portions of several buried, 0.2-m³ (55-gal) metal drums (see Fig. 5.2). No significant levels of beta-gamma radiation were detected in the hole, although levels were slightly above background. At another remote area northeast of Hot Yard Road, an old transformer/capacitor device, partially covered with a dark, oily substance, was found on the ground surface (see Fig. 5.3). This may suggest possible PCB contamination and the potential for additional PCB-containing materials on the site. In addition, a sealed glass bottle containing an unidentified liquid (Fig. 5.4) was found in the ORNL area of the site. These findings further emphasize the need for a more thorough site assessment of possible hazardous waste contamination. The potential for subsurface soil and groundwater contamination from fugitive hazardous waste at the White Wing Scrap Yard site exists because of the types and large quantities of scrap debris that have been and continue to be subjected to erosion by wind and water. Subsurface drilling into these suspect areas with subsequent RCRA Extraction Procedure Toxicity Characteristic tests and radiological analysis of core samples should be considered.

Fig. 5.2. View of ground-surface subsidence where buried metal drums were found at the White Wing Scrap Yard site (January 1990). Reportedly this region was used by ORGDP.

- Isolation procedures (i.e., roping) should be considered at the area of surface subsidence prior to mixed-waste analysis and subsequent verification of drum contents. Detailed subsurface characterization of this immediate area is recommended prior to drum removal. Additionally, radioactively contaminated metal drums found on the ground surface should be removed and disposed of in a designated radioactive waste disposal site.

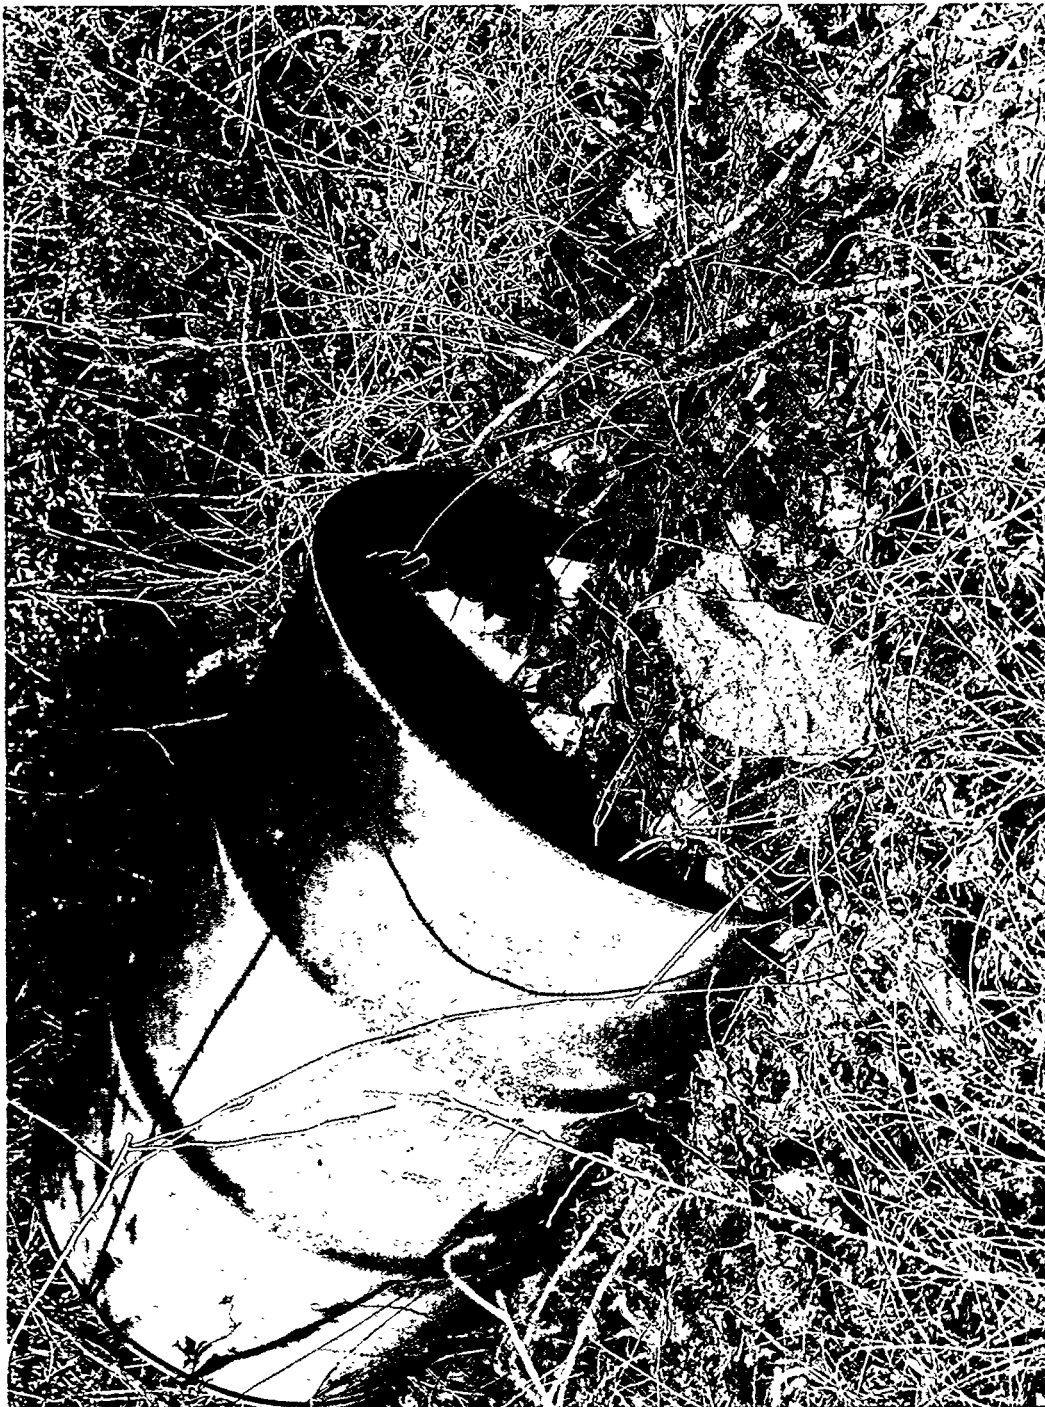
4. Long narrow strips of apparent asbestos material were found on the ground surface and/or partially buried in soil matrix at several locations north of Hot Yard Road. Additionally, a 0.2-m³ (55-gal) metal drum containing apparent asbestos material (Fig. 5.5) was found in the ORNL area, south of Hot Yard Road. Verification of asbestos and identification analysis for specific asbestos fibers by ORNL Industrial Hygiene personnel cannot be completed because these materials were radioactively contaminated.¹⁰ Elevated beta-gamma activity levels were measured on contact with the plastic sample bag. There is a low probability of airborne asbestos hazards due to the solid texture of the asbestos material. Additionally, wet or moist conditions that existed during the course of the survey reduced the potential for hazardous levels of airborne asbestos.

Fig. 5.5. Metal drum containing apparent asbestos material that is radioactively contaminated at the White Wing Scrap Yard site (February 1990).
